RETROUT River Restoration Demonstration Case Reports

RETROUT project report

For bibliographic purposes this document should be cited as: "RETROUT 2021. RETROUT River Restoration Demonstration Case Reports. Interreg RETROUT project.

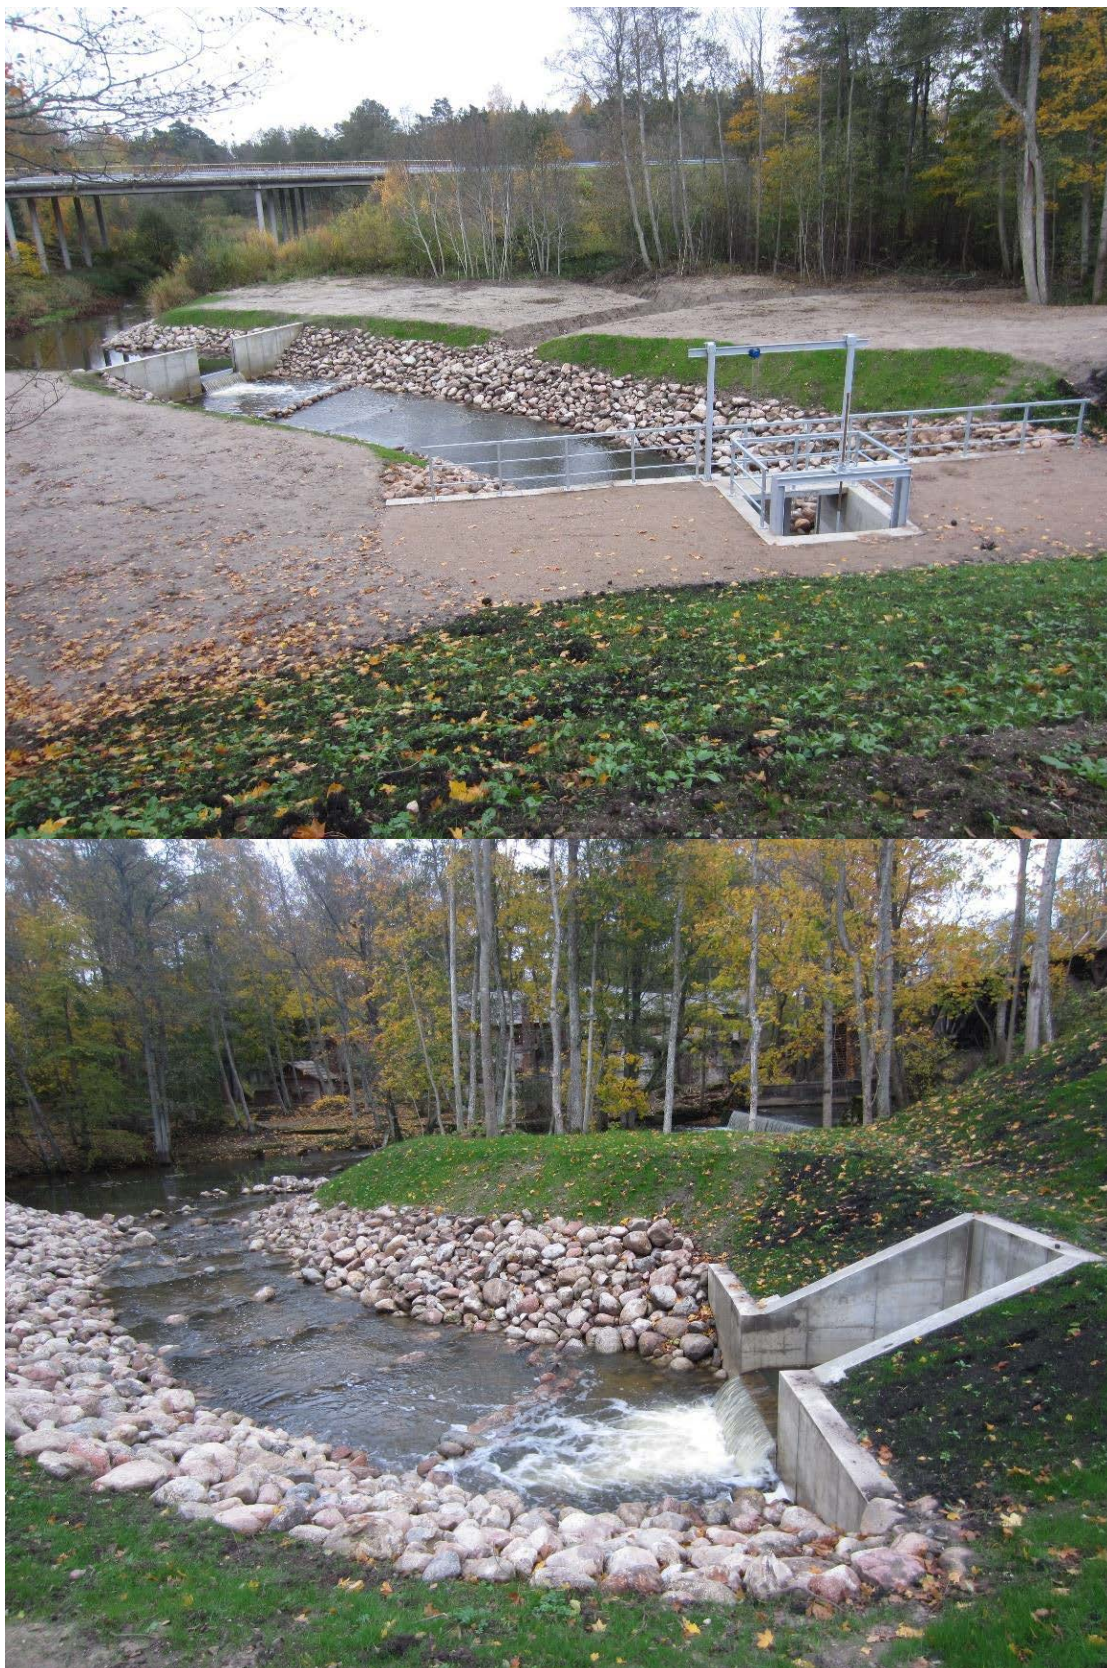
During further investigation it was made clear that the received alarmed signals from several parties about what is happening in the Rīva river were correct (Figure 25). So far, it had been announced with great confidence that the first natural fish pass in Latvia was being built in the Rīva river and it was to be suitable not only for sea trout but also for other fish and invertebrates. However, at this point the fish pass did not meet those expectations. It was found out that partly due to a faulty design and partly due to faulty construction work, the new fish pass had severe problems, inter alia in form of three new obstacles effectively obstructing fish migration. Also, 200 mm pipes had been laid in the channel controversially to aid fish migration. During low water conditions, there was extremely little water in the channel for the fish. It became clear that the design of fish pass in the late stage of the planning process had been changed without involvement or consultation of BIOR and RETROUT partners. The emerged concerns were expressed, and the involved parties started to search for a solution. Two meetings in the river side were held. A situation explanation and pictures were also sent to RETROUT project experts Martin Kesler (Estonia) and Robertas Staponkus (Lithuania), who also participated in a

meeting at Rīva river to provide external expert consultation. It was concluded that sufficient water in the fish pass was secured only during high flows (Figure 26); in medium and low flow conditions water flow over the obstacles is poor.

Figure 25. The fish pass site after construction in October 2020. Photo credit: Ventspils county municipality.

On 9th October 2020 a meeting was held with all Latvian restoration project partners, designers of the fish pass, constructors and local stakeholders. After long discussions, practical checking and measurements on the spot, a compromise solution that satisfied both scientists and local stakeholders was found. It was decided that the designers make the corrections in the design of the fish pass to ensure migration possibilities for different kinds of fish and at the same time secure enough water for the main channel to retain the artificial waterfall as a tourism attraction. Openings were to be made in both of the most crucial new obstacles. The dimensions of the openings were calculated so that the bottom of the opening was 10 cm lower than the bottom of pipe in the uppermost obstacle in the main river. And the width of the opening was calculated so that during the low flow the fish pass will consume approximately one half of the flow and other half will be left for the waterfall in the main river. In addition, parties agreed that the stone piles in the fish pass will be left unchanged and the upstream parts of the pipes in the stone piles will be clogged with smaller stones. The wooden shields in the uppermost part of the culvert were to be removed.

Changes in the construction were done properly and according to decided solutions and design. Additional costs caused by the situation were covered partly by the construction company within its responsibility and partly by the Ventspils County municipality. Thereafter the fish pass has been in operation. Further monitoring of the functionality of the fish pass in various conditions will be carried out during the coming seasons.

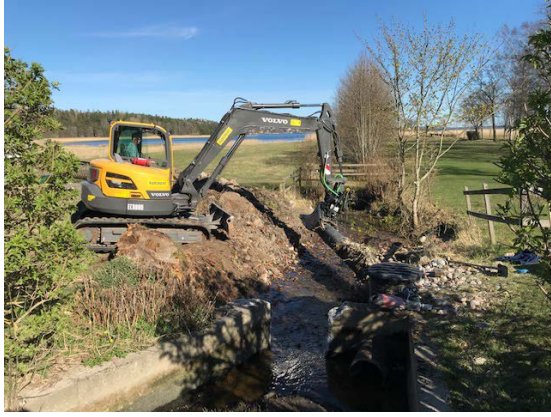
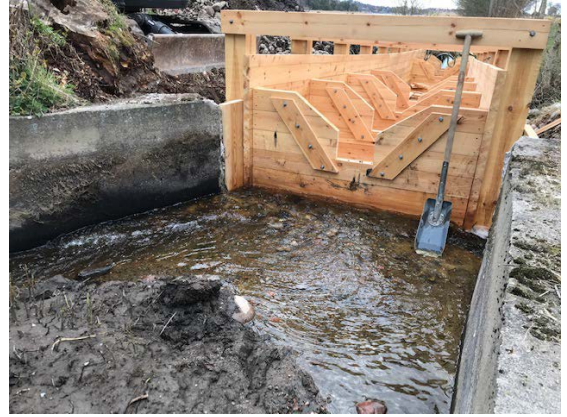
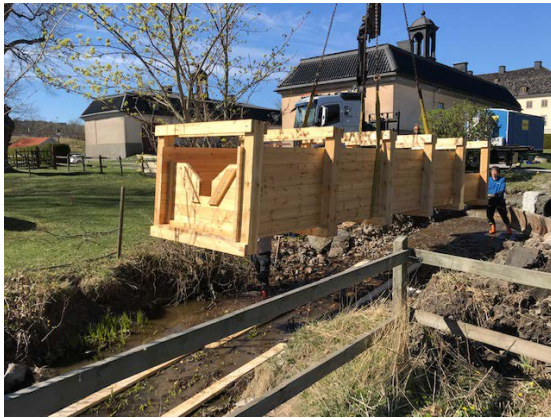
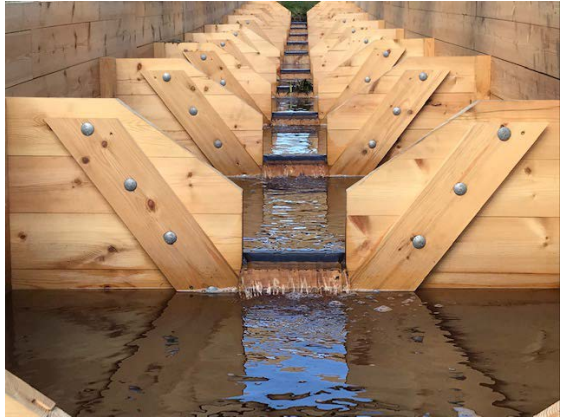
Figure 59. The old fish pass is removed (upper left) and the new one is installed. When the leak was sealed all pools was filled as planned (lower right). Photo: Oliver Karlöf.
