RETROUT River Restoration Demonstration Case Reports

RETROUT project report

For bibliographic purposes this document should be cited as: "RETROUT 2021. RETROUT River Restoration Demonstration Case Reports. Interreg RETROUT project.

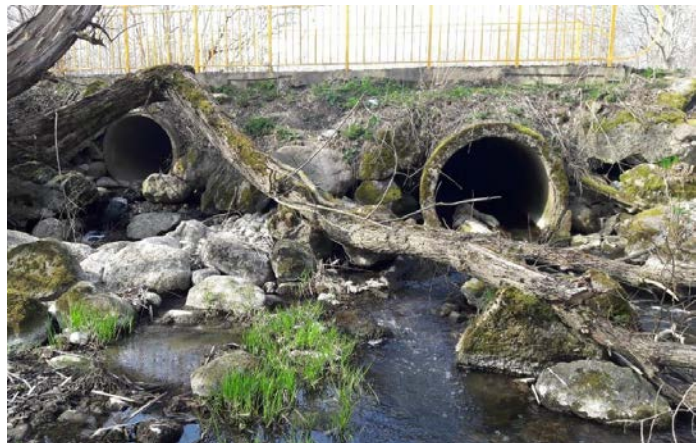
A possible problem with the selected site is that there are two poorly maintained road culverts in Smiltaitē tributary 1.5 km downstream the restoration site. One of the culverts is open for migratory fish only during high flow conditions, the other has a concrete block blocking passage (Figure 33).

Figure 33. The two culverts that constitute migration obstacles.

To improve the suitability of the site for sea trout the riverbed has been modified because of lack of stones and gravel. A site which is known to be suitable for sea trout upstream the restoration site was used as a target (Figure 31). The planned actions included three sites, together 150 m and 600 m² where spawning grounds and nursery areas would be created (Figure 32). To ensure accessibility to the site, plans to remove the road culvert downstream the restoration site was made.

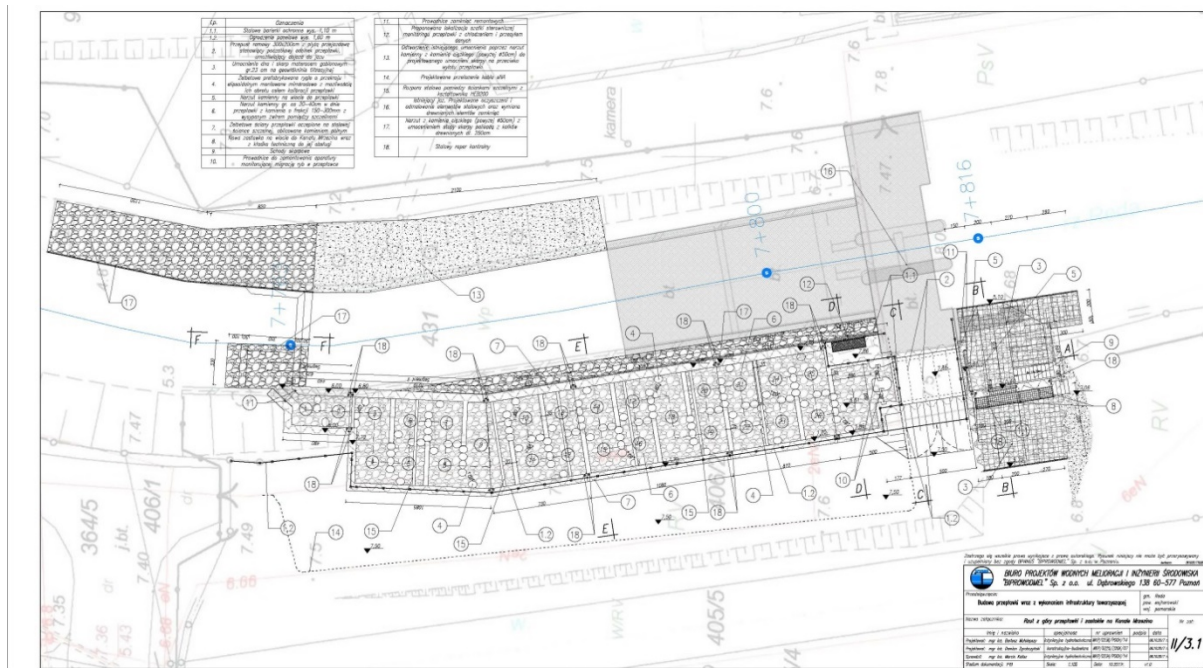
Figure 37. Planned fish pass in Reda – technical drawing. Credits: National Water Holding “Polish Waters”.

- Strengthening the Reda bottom with a gabion mattress at the bottom of the fish pass
- Profiling and strengthening the slope with a stone rip-rap between the fish pass and the Reda river bed
- Panel fencing along the left wall of the fish pass
- Leveling the area around the fish pass to the ordinate of 7.50 m above sea level
- sowing with a mixture of grasses on the humus of the area between the fish pass and the Mrzezino Canal on the plot no. 406/2 (Figure 37).

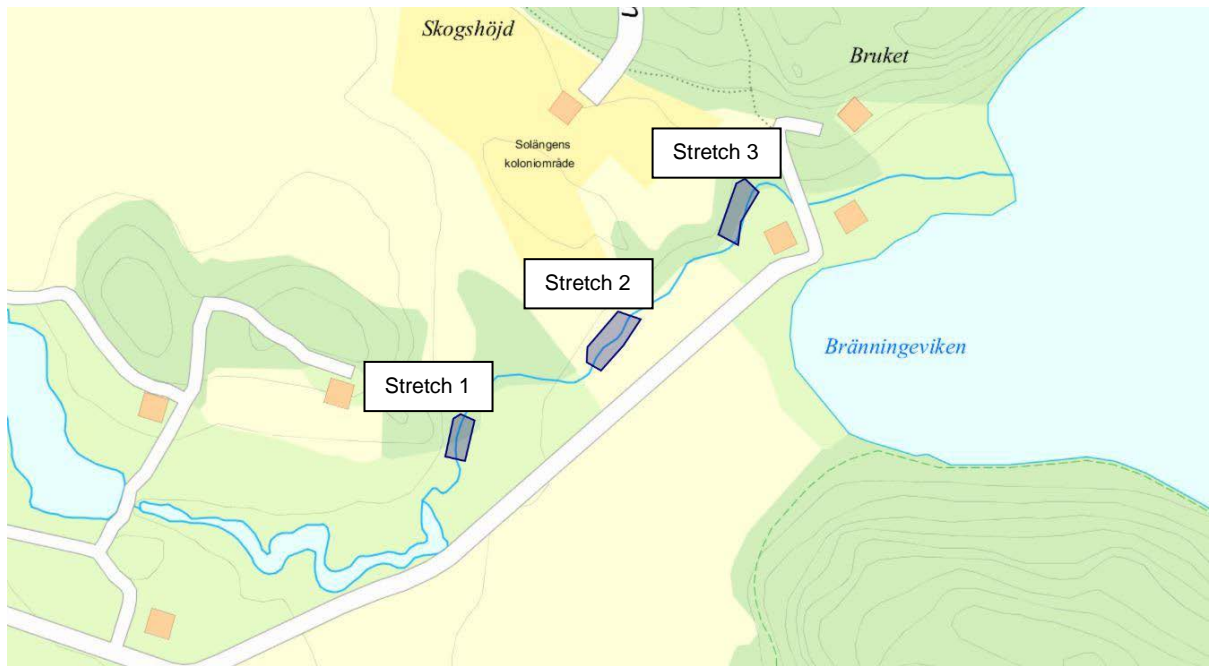
In 2018 and 2019, the restoration work in Bränningeån continued upstream of the previously restored stretches (Figures 43 and 44). The restoration activities were carried out in two stages. The actions at stretches 1 and 2 (Figure 43) were implemented from 24 to 26 September 2018. Stretch 3 was restored on January 28, 2019. The reason that stretch 3 was restored in January was due to soft and sensitive ground conditions.

Figure 43. The three restored stretches.

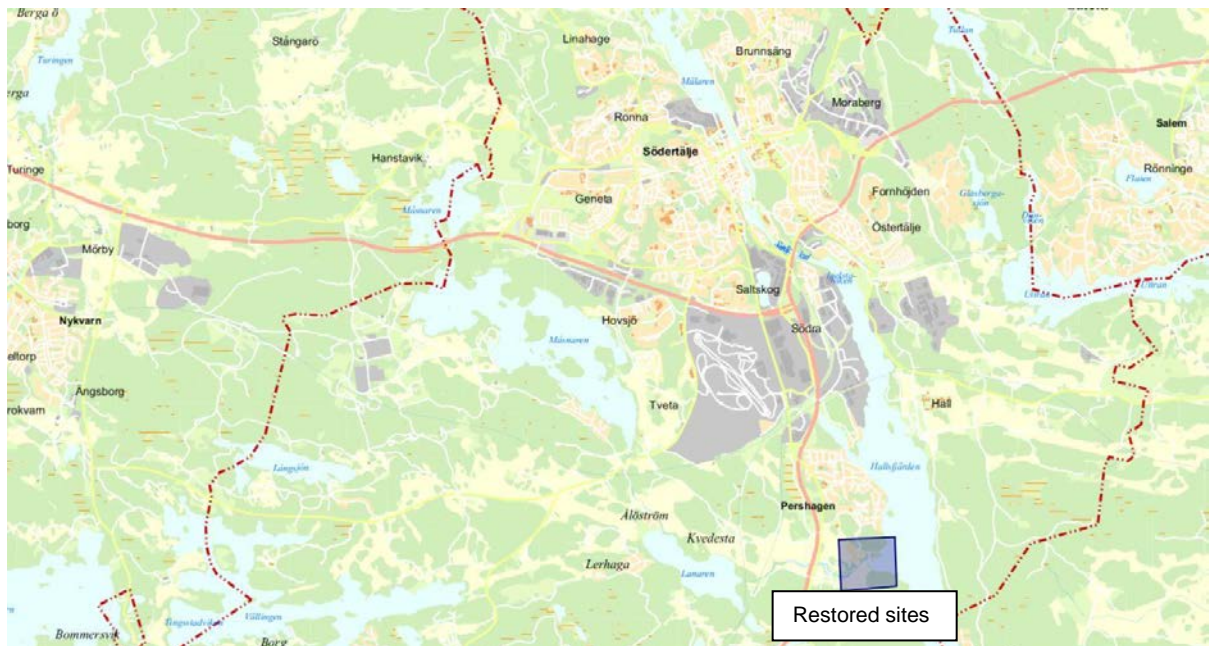
Figure 44. Overview of the restoration sites.

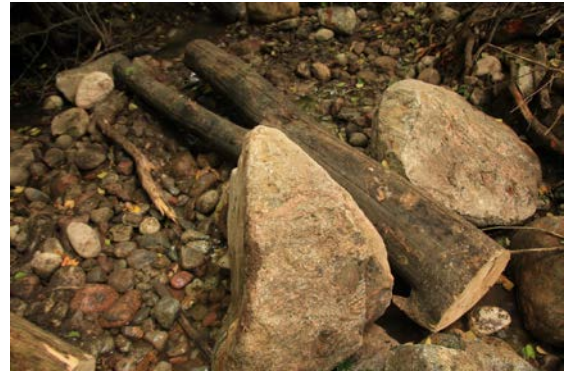
Figure 46. Logs and larger stones create hiding places, structure and holding spots. The picture is from stretch 2. Photo credit: John Kärki.

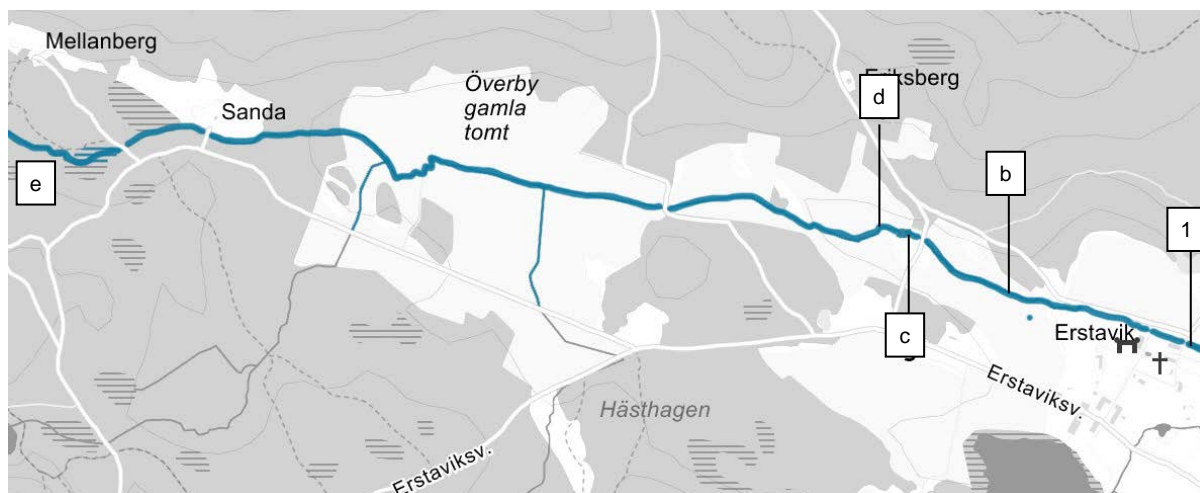
Based on the electrofishing and river habitat survey data it is concluded that that the poor status of sea trout (and river lamprey) is at least in part caused by the migration obstacles and poor river morphology. Possible restoration activities include removal or improvement of the fish pass, tree planting in the riparian zone, habitat improving measures e.g., re-introducing gravel and large stones to create spawning grounds and holding spots. The planned restoration activities are described in Figure 56.

Figure 56a-e. The letters refer to comments and photos below. Photo: Oliver Karlöf.

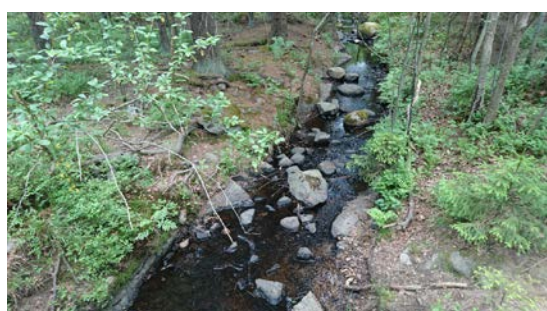
e. Potential spawning grounds close to the source lake (Sandasjön)

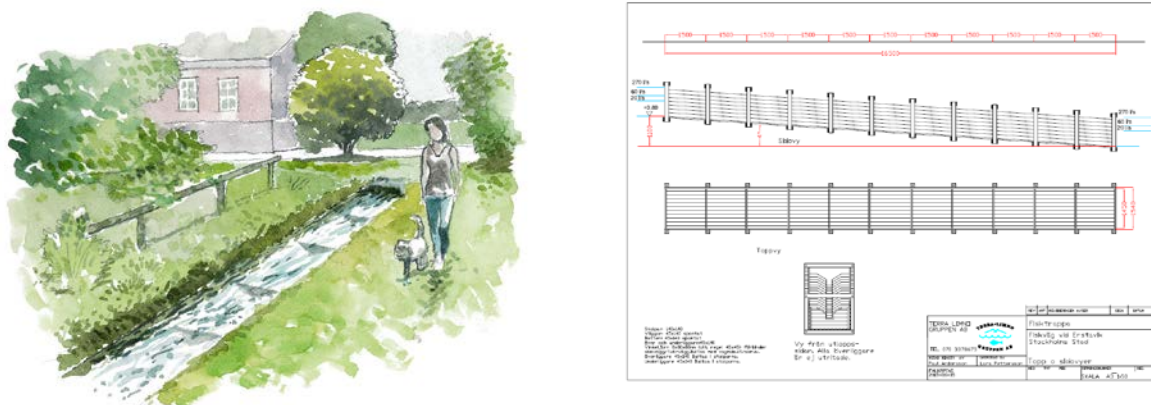
Figure 57. illustration of the fish pass in the planned setting (left). Technical sketch of the fish pass (right).

The planning involved five organisations, The County Administrative Board of Stockholm, The City of Stockholm, the Swedish Angling Society, Nacka municipality and the landowner. A design company was procured. The design was discussed with the planning group which decided to build the fish pass in wood (Figure 57). The activity will be followed-up as part of the regular electrofishing monitoring programme by the city of Stockholm. Redd counts will be performed as well.

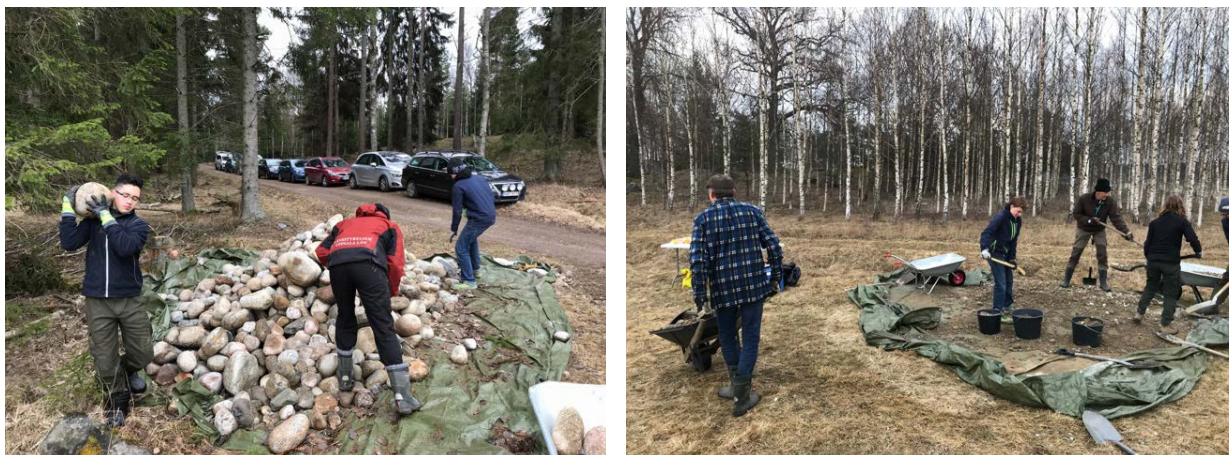
Figure 58. Members of Saltsjöbadens fiskevårdsförening and Enskede Fiskeklubb volunteering to work with habitat improvement measures upstream the fish pass in Erstaviksbacken. Photo: Oliver Karlöf.

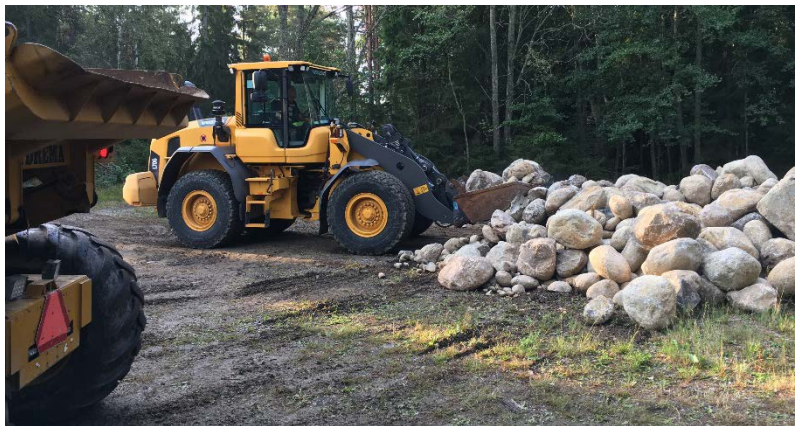
Figure 66. Dumpster in action at the Vitså mill site.

At the Vitså mill site, stones of different sizes took were deployed on August 16-17, 2018 on an approximately 120 m long stretch upstream of the former dam building (Figure 66, 67). Coarser stones were laid at the bottom of the riverbed with smaller fractions on top. Some deeper parts were saved to create an as varied environment as possible. Several larger logs were placed in the watercourse. The water level was very low at the time of the action. The work was carried out by the Haninge Municipality's construction and works department with a track-borne 14 tonnes excavator, one wheel-borne 14 tonnes excavator and a dump truck. A transport road was built with canvas and gravel down to the river from the road at the former dam building. The transport road was then removed when the work was completed.

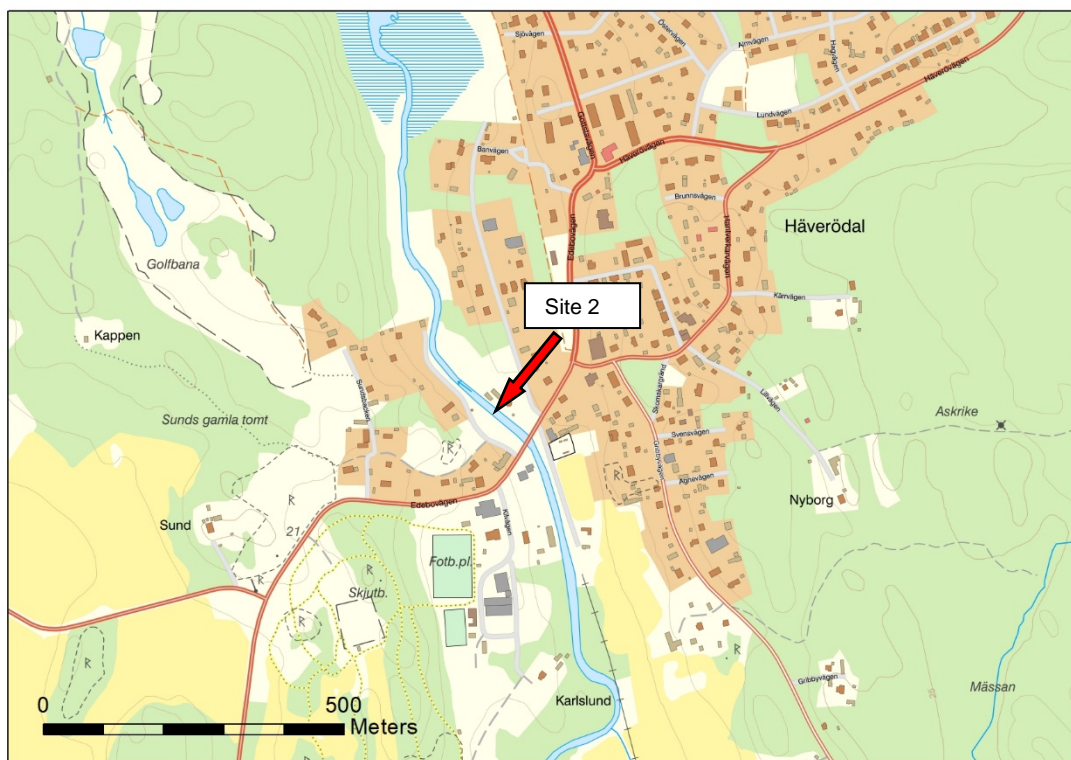
Figure 77. Stretch 2, Häverödal old mill and saw. Here habitat improvement measures were applied, and a controlling section partly restored.

At Häverödal the formerly cleared river has now a more variable structure and a partly restored controlling section. Already 32 sea trout have been observed to spawn at the newly restored stretch. The electrofishing and redd counts next and the following years will give us more information about the result of the restoration activities.

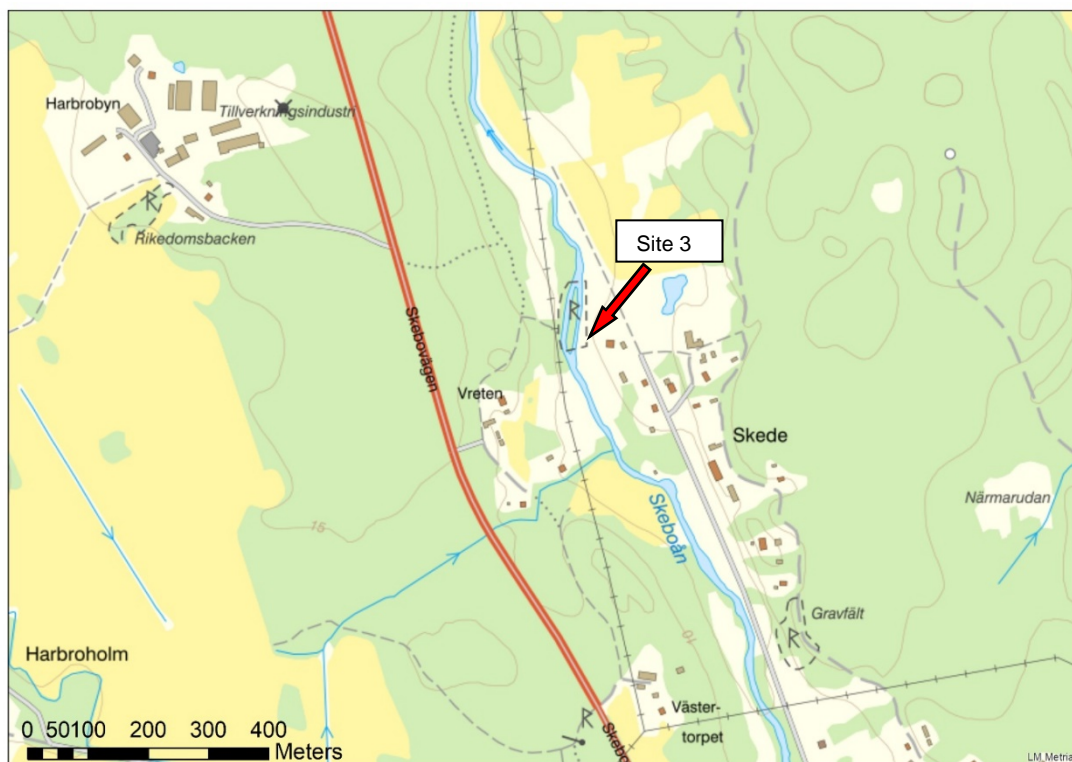
Figure 78. Stretch 3, Skede ironworks. Here, habitat improvement measures are planned. The site is a historic site protected by the Ancient Monuments Act.

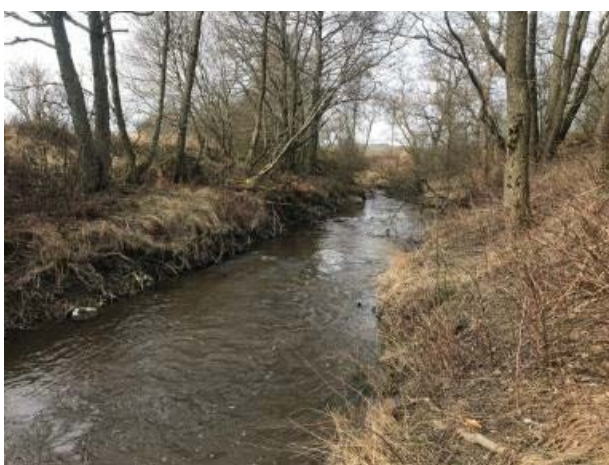
Just downstream the nature reserve Moraåns dalgång (the Moraån valley) is a stretch which have been redug and cleared, but still has moderately fast flowing water (Figure 85). The riverbanks are tree lined but steep because of a removed controlling section downstream (Figure 86). Hence, the river has lost contact with the original flood plain and secondary flood plains have started to form. The stretch is suitable for habitat improvement measures including adding stones and gravel to the river because the water is not completely calm, and the riverbed is not too soft; added stones will not be buried in sediment. By adding large stones, logs, and gravel we hope to increase biodiversity and create holding spots and spawning grounds for sea trout.

Figure 86. Restoration site at Norrbyvälle. Photo: Ekologigruppen AB.
